Zenair Europe

Service Letter

S.L. Number:	ZE-2009-01
Date of issue:	June 1, 2009
Subject:	Verification of the proper installation of the “Flap Stops” (Part N° 6S3-1)
Affected Models:	All Zenair Zodiac CH 601XL/CH 650 (ULM and Homebuilt Models).
Serial Number(s)	All
Manufactured by:	Czech Aircraft Works (CZAW) and others.
Purpose:	The purpose of this S.L. is to ensure that all affected models are only flown when “Flap Stops” are installed.
Directed Action(s):	<p>a) Before the next flight, inspect the outboard area of the flap gaps on the top surface of each wing, to establish that the “Flap Stops” have been properly installed (see illustrations on page 2).</p> <p>b) When properly installed, the flaps come to rest against the “Flap Stops” when in the “up” (retracted) position. There should be no free-play at the trailing edge of the flaps when flaps are in the “up” position (snug against the Flap Stop).</p> <p>c) If not installed (see photo below), obtain and install the missing parts according to this S.L. before the next flight.</p> <div data-bbox="764 1272 1212 1536" data-label="Image"> </div>

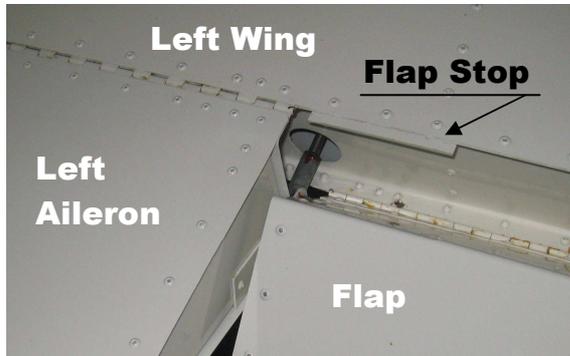
1) When in the “up” position, the flap must rest against a plastic “flap stop” (see photos below). Both left and right flaps must be touching the stops when flaps are retracted (“up”).

Left flap shown in “down” position

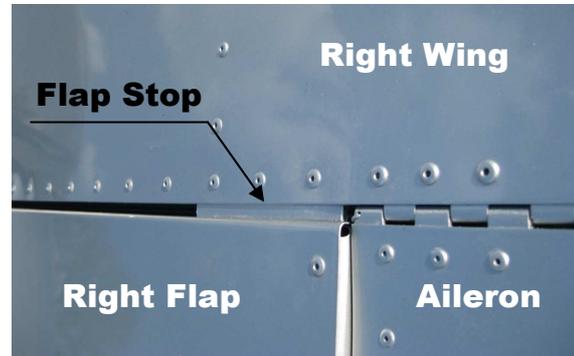
Flap up (against the flap stop)

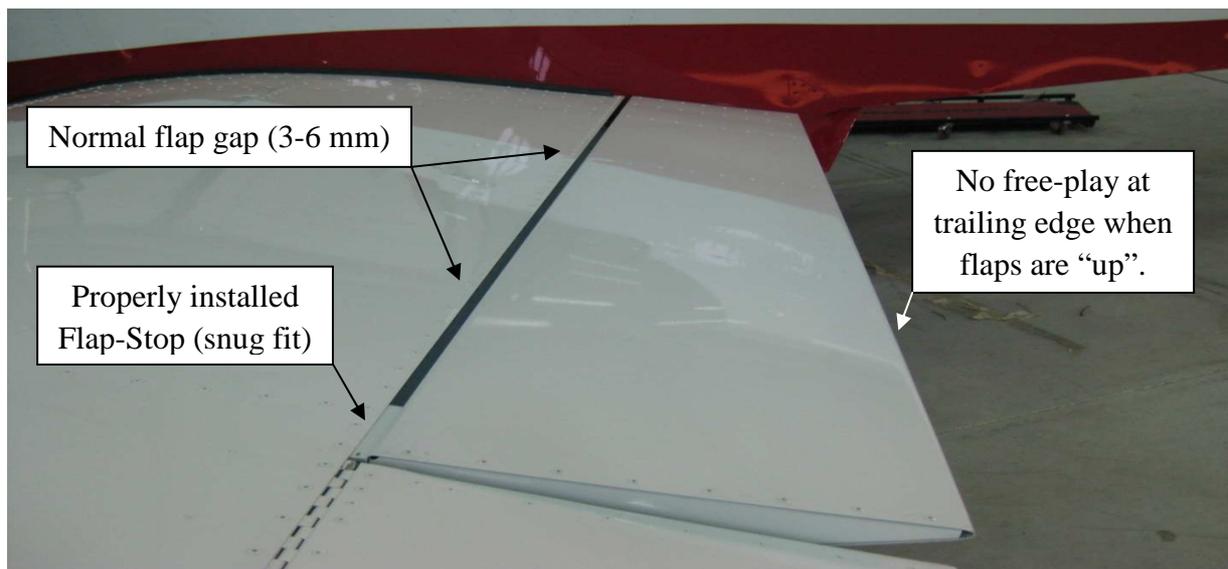
2) There should be no free-play in the flaps when they are in the “up” position (test by applying light up-then-down pressure to the trailing edge). When flap stop (6S3-1) is installed as illustrated, no further action is necessary.
